## Treescan Urban Forest Management's Tree Report

# TREE REPORT

*Platanus x hybrida* (London Plane)  
in Chapel St Richmond

For  
Hawkesbury City Council  
October 2005

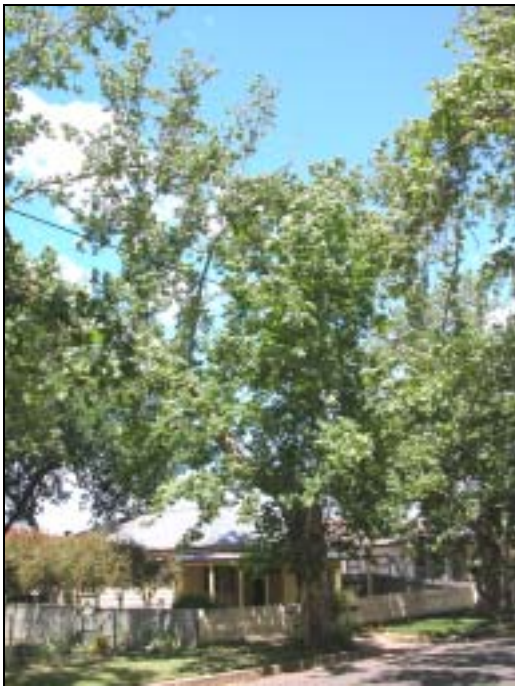
Plate 1: Tree 1

Trunk diameter 830mm, crown spread approximately 8m, height approximately 12m. In poor health, with extensive branch dieback in the upper crown. All major branches and the lower trunk bear prolific epicormic shoots.

In poor structural condition, having been severely lopped in the past for power line clearance.

Dying branches overhang the property. The crown dieback, coupled with the production of epicormic shoots, indicates decline, possible due to root system problems.

This tree is severely hazardous due to extensive defects and its location in a high traffic area. It should be removed and replaced. There is no requirement to undertake Resistograph investigation since the defects are severe and assessable externally.

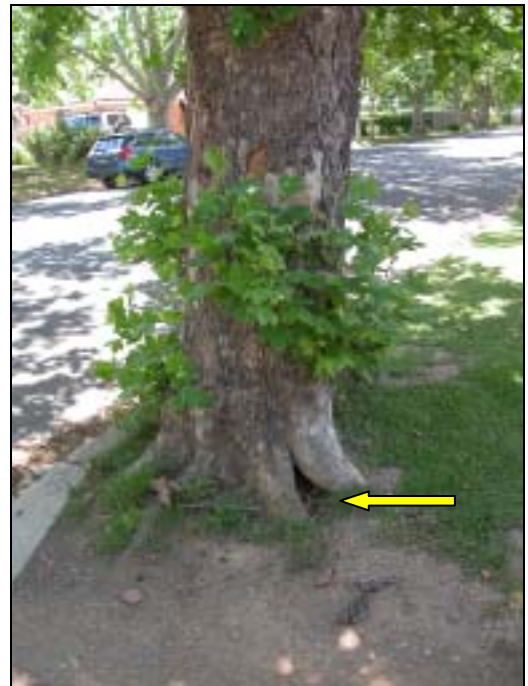
The root crown is confined by the kerb and gutter, and by a highly compacted gravel driveway to the south of the trunk. No surface roots are visible. There is severe soil compaction within the footpath area with grass between the footpath and the kerb.

There is an extensive cavity in a major root buttress to the south of the trunk. The cavity extends at least 500mm into the trunk centre. This buttress is one of only two large root flares supporting the tree and its weakness indicates that the tree is likely to be unstable. There do not appear to be any roots on the western, kerb, side of the trunk, although the sandstone kerb has been moved and cracked by girth expansion.

Plate 2: kerb and driveway showing decayed root

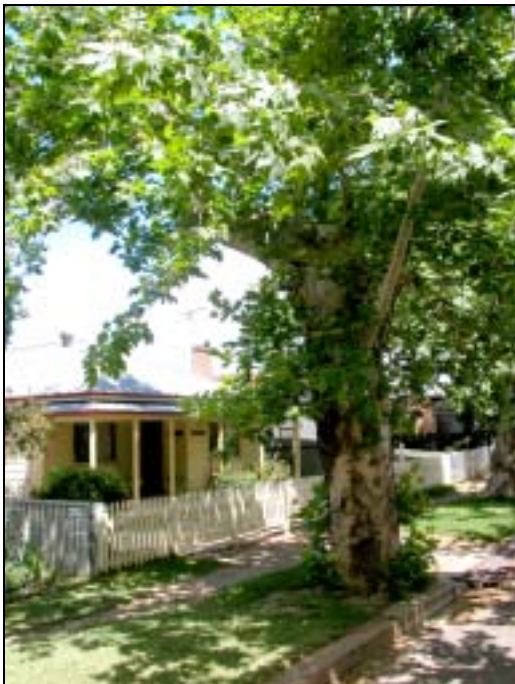
The trunk turns at approximately 4m height with an extensive cavity present at the change of direction presumably from an old lopping wound. This is a point of likely failure. The trunk ascends at 45° as far as the boundary of the adjacent property then turns to the vertical. There is a pronounced rib on this section of the trunk indicating an attempted reinforcement of a weak structure.

Plate 3: subtrunk overhanging neighbouring property

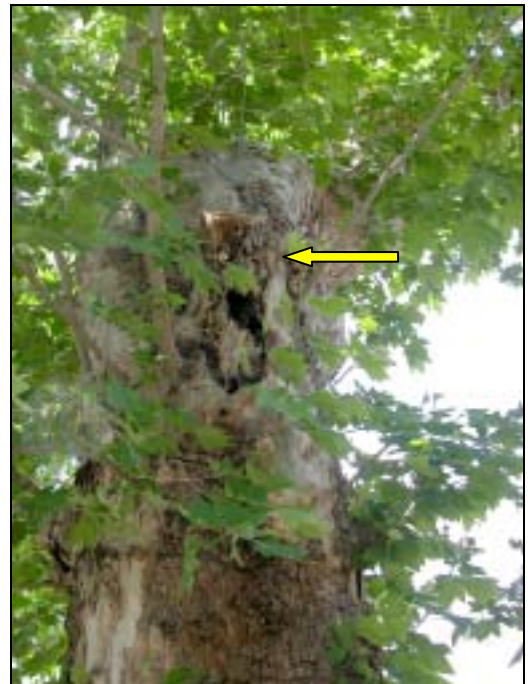
Plate 4: decaying stub in subtrunk

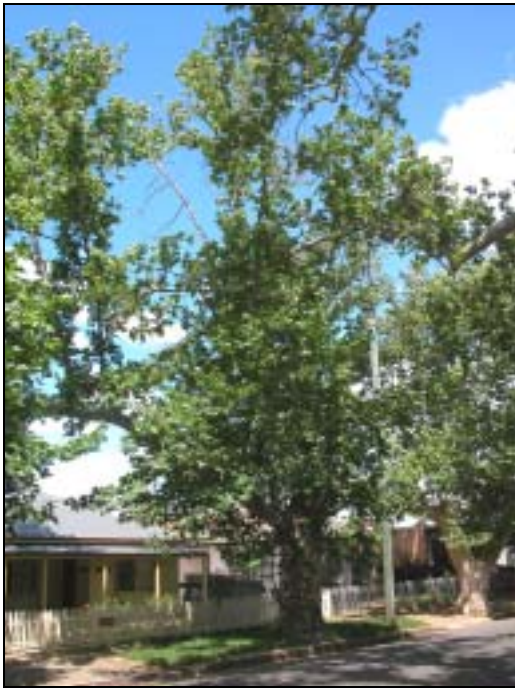
Plate 5: Tree 2

Trunk diameter 920mm, crown spread approximately 14m, height approximately 15m. In poor health with extensive branch dieback in the upper crown. All major branches bear prolific epicormic shoots.

In poor structural condition as the result of lopping for power line clearance in the past.

This tree is severely hazardous due to extensive defects and its location in a high traffic area. It should be removed and replaced. As an alternative, the subtrunks could be lopped down to a height of approximately 6m and the regrowth managed. This may allow its retention for a few years. Resistograph investigation of trunk and subtrunks would be required prior to the adoption of this program and regular inspections would be required.

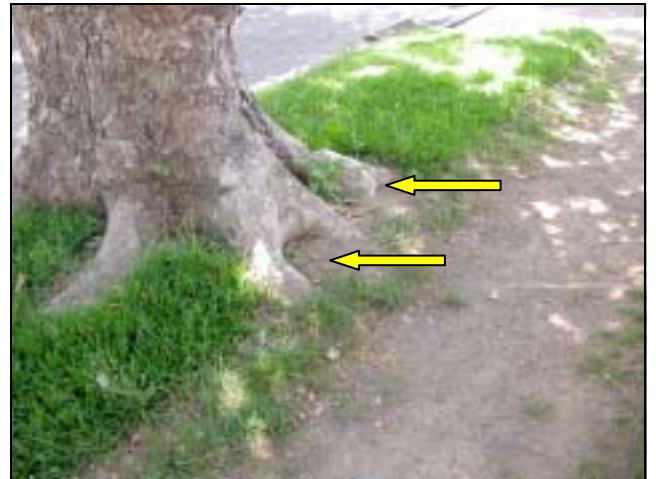
The root crown is confined by the kerb and gutter, which is being lifted by root activity. Only one small surface root is present, within the footpath surface. The major root buttresses to the east of the trunk appear to have been severed in the past and have regenerated. There is a significant bulge in the lower trunk over a root buttress to the south of the trunk, possible evidence of internal decay. The lower trunk also exhibits a prominent fibre buckle around much of the circumference at approximately 1m height, possibly indicating weakness at this point.

Plate 6: root buttresses apparently severed and regenerated

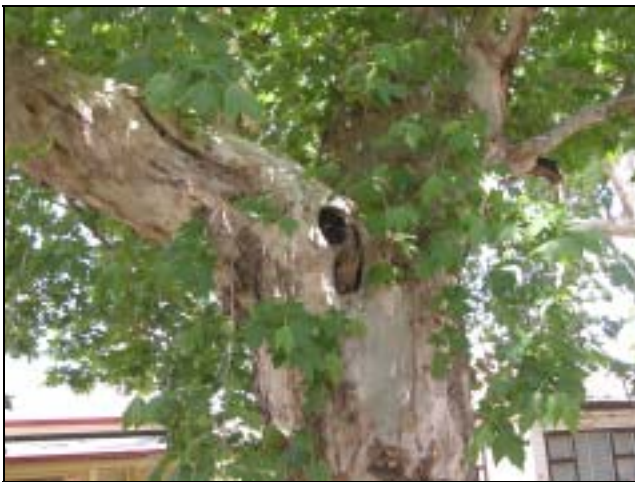
The lower trunk divides into two major subtrunks. There is a large cavity in the eastern subtrunk, which overhangs the neighbouring property, 12 Chapel St. The upper section has severe branch dieback and there is a wound with significant decay at a branch junction. The northeastern subtrunk has been lopped to the boundary and a large vertical epicormic shoot arises at this point. There is a deep cavity at the junction with the lower trunk and decay may extend into the heartwood. A lopped and decayed stub extends over the roadway.

Plate 7: Cavity at main junction

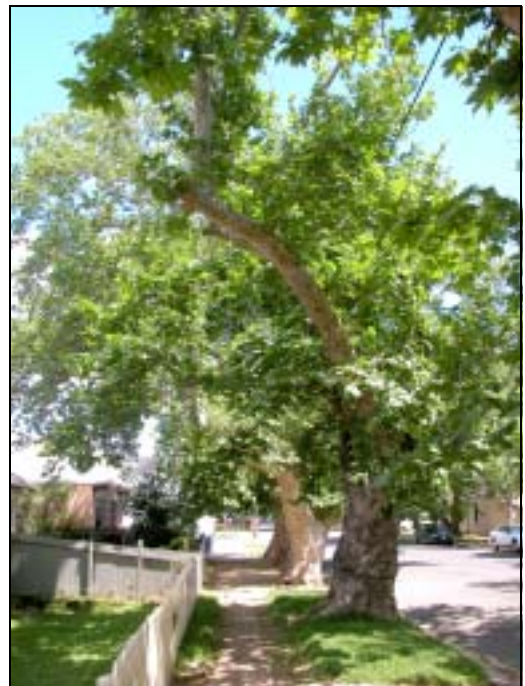
Plate 8: subtrunk overhanging boundary with large epicormic shoot

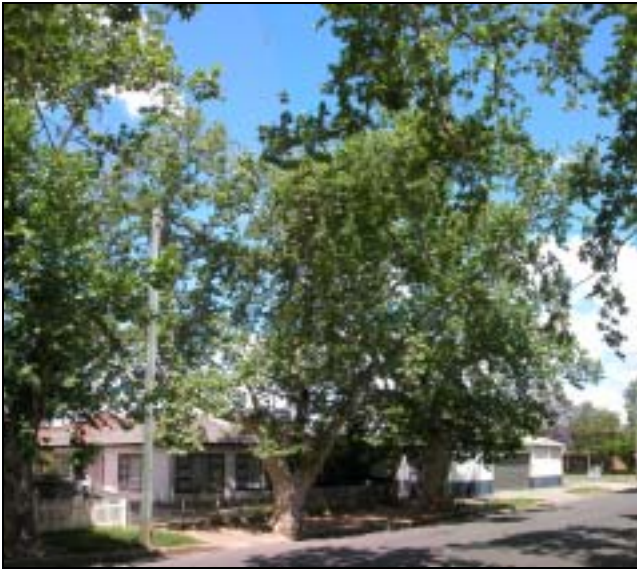
Plate 9: Tree 3

Trunk diameter 830mm, crown spread approximately 15m, height approximately 14m. In fair health with a reasonably dense leaf coverage of the crown, but with epicormic shoots along all branches and subtrunks.

In poor structural condition, having been severely lopped for power line clearance.

This tree is severely hazardous due to extensive defects in the root system and scaffold, and its location in a high traffic area. It should be removed as soon as possible and replaced. There is no requirement to undertake Resistograph investigation since the defects are severe and assessable externally.

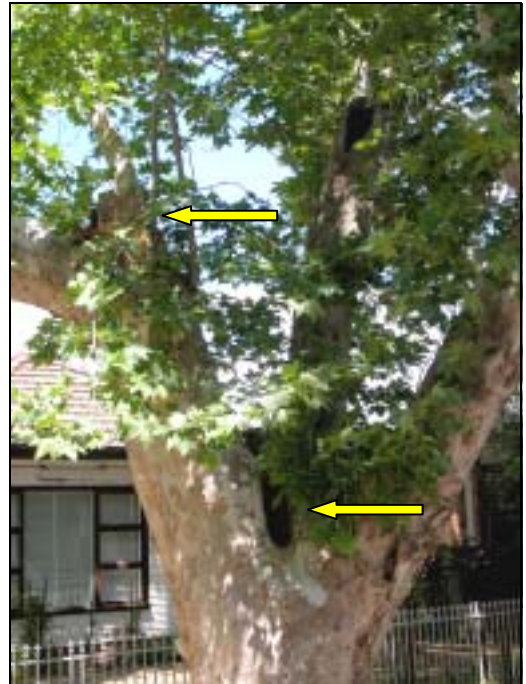
The lower trunk divides into three subtrunks at about 2m height. There is a major cavity at the junction and a deep hollow which extends into both the subtrunk and the lower trunk. There is a pronounced bulge below the cavity, indicating an area where reinforcement is occurring in an attempt to strengthen the weak point. Failure is likely in this area.

The eastern subtrunk extends over the neighbouring properties of 12 and 14 Chapel St, with a large epicormic shoot approximately 200mm in diameter growing vertically from the limb. A decayed stub is present where the original subtrunk was lopped for power line clearance and decay may extend into the heartwood. This is a point of likely failure. A lateral branch overhanging 14 Chapel St has an acute change of direction at a lop wound and is weak at this point.

Plate 10: cavity at junction (lower arrow) and decayed stub in subtrunk

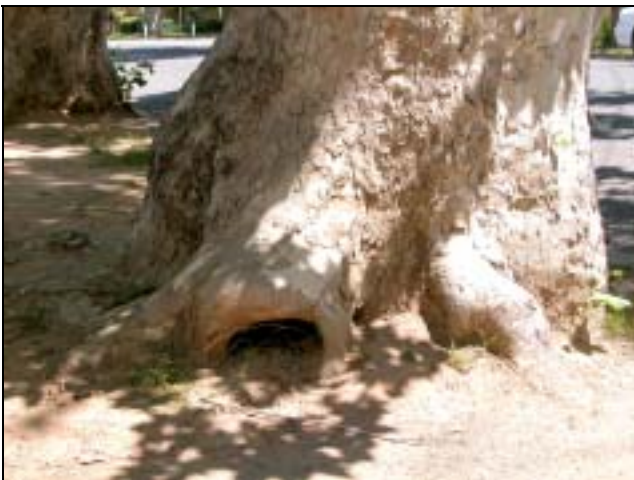
There is a cavity in a major root buttress to the northern side of the trunk to a depth of at least 700mm towards the trunk centre: this root appears to have been severed for driveway construction. This weakness may render the tree unstable. In addition there are bulges over buttresses to the south and east of the trunk indicating possible decay.

Plate 11: decayed root at edge of driveway

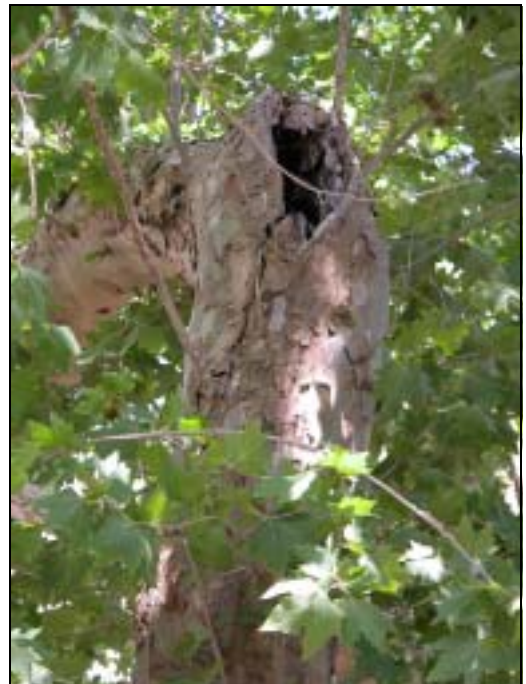
The southern subtrunk overhangs 14 Chapel St and has a major cavity at a change of direction. The wood below the cavity has an extensive crack, indicating imminent failure. The branches are lopped at the boundary and vertical epicormic shoots are in contact with the upper crown of Tree 4.

Plate 12: Cavity in subtrunk at change of direction

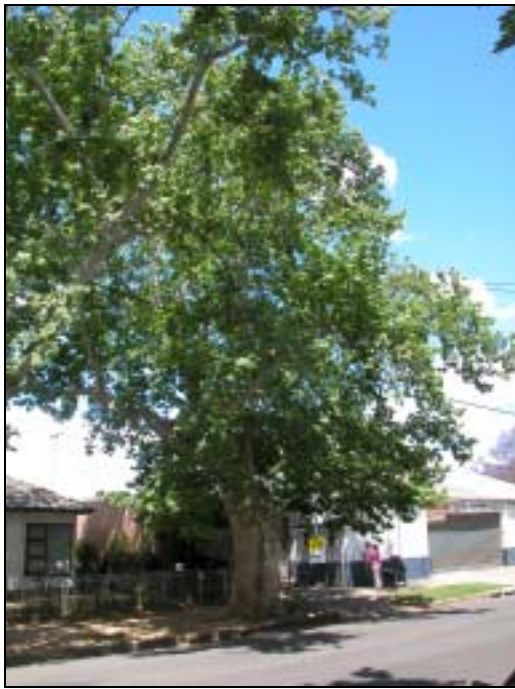
Plate 13: Tree 4

Trunk diameter 1000mm, crown spread approximately 18m, height approximately 12m. In fair health with a reasonably dense leaf coverage of the crown, and with less prolific growth of epicormic shoots.

In poor structural condition, having been severely lopped for power line clearance.

This tree is severely hazardous due to extensive defects and its location in a high traffic area. It should be removed and replaced. As an alternative, the subtrunks could be lopped down to a height of approximately 6m and the regrowth managed. The kerb and gutter should be realigned to form a bubble into the roadway and the adjacent driveway reconstructed over the major root. These measures may allow its retention for a few years. Resistograph investigation of trunk and subtrunks would be required prior to the adoption of this program and regular inspections would be required.

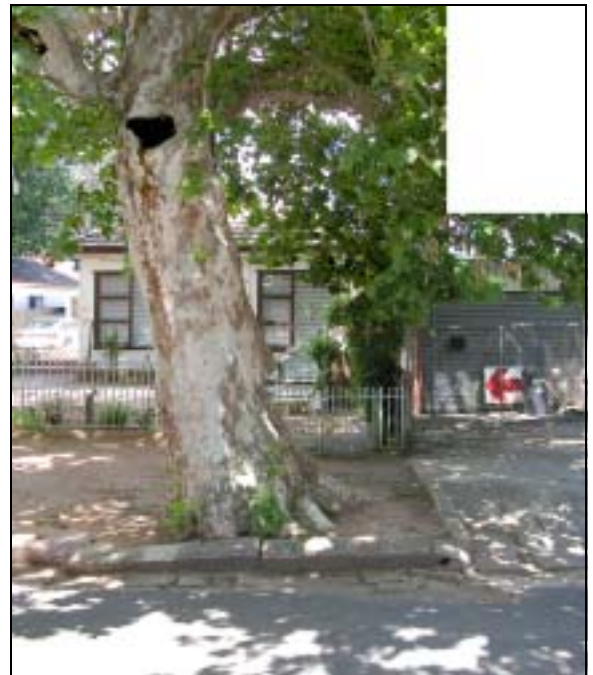
The root crown is confined by the concrete driveway immediately to the south and by the kerb and gutter. Extensive damage to the driveway has occurred, and the sandstone kerb and gutter has been lifted and cracked. Major surface roots extend into the front garden of the adjacent 14 Chapel St.

Plate 14: Damage to kerbing and driveway

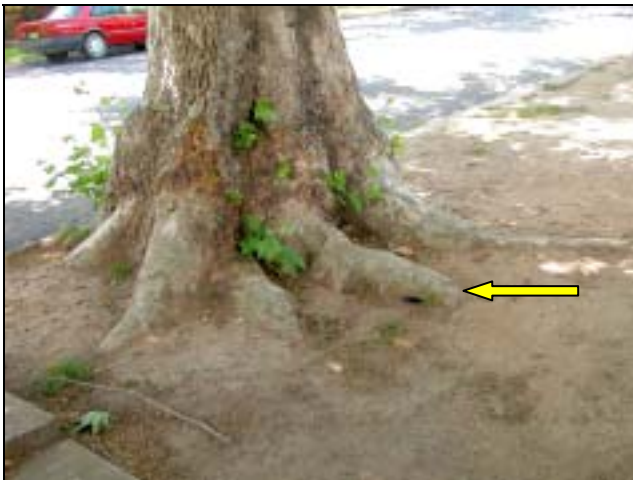
There are distinct bulges or fibre buckles over the root buttresses to the south and east, possibly indicating the presence of heartwood decay. A major root to the east of the trunk is either decayed or is lifting, since there is a void at least 700mm in depth under the root. The major supporting root to the south is lifting the concrete driveway, and reconstruction of the driveway would entail cutting this root. Similar problems would occur if reconstruction of the kerb and gutter takes place.

Plate 15: Root decayed or lifting, void under

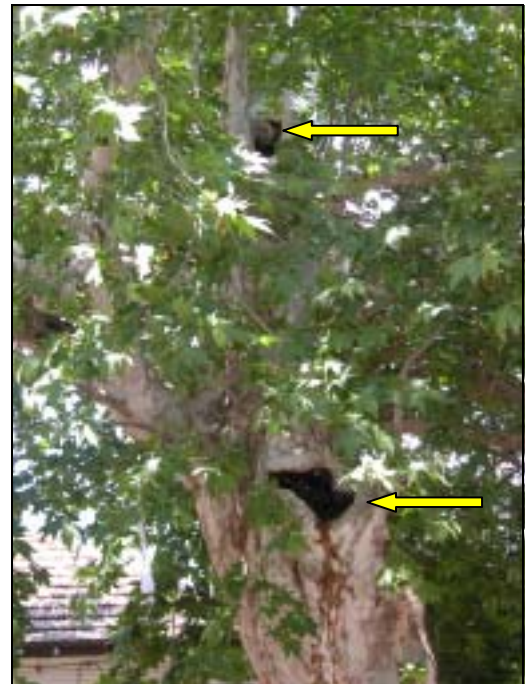
The main trunk contains a large decayed cavity at approximately 3m height, the decay probably extending into the heartwood. This wound contains bacterial wetwood. Failure may occur at this point.

The eastern subtrunk contains a major cavity at approximately 6m height. This subtrunk forms the upper crown and overhangs 14 Chapel St. Failure is likely at this point.

Plate 16: cavities in lower trunk and subtrunk
